**Environmental Due Diligence  
Assessment, Phase I,  
Icopal, Høland, Norway**

Title Environmental Due Diligence Assessment, Phase I, Icopal, Høland ,  
Norway  
Client Nordisk Wavin A/S  
Project Leader Mr. K.E. Braams BSc  
Author Mr. K.E. Braams BSc  
Project Number 3911373  
Number of pages 34  
Signature

# The Icopal Facility in Høland, Norway

Environmental Due Diligence (Phase 1)

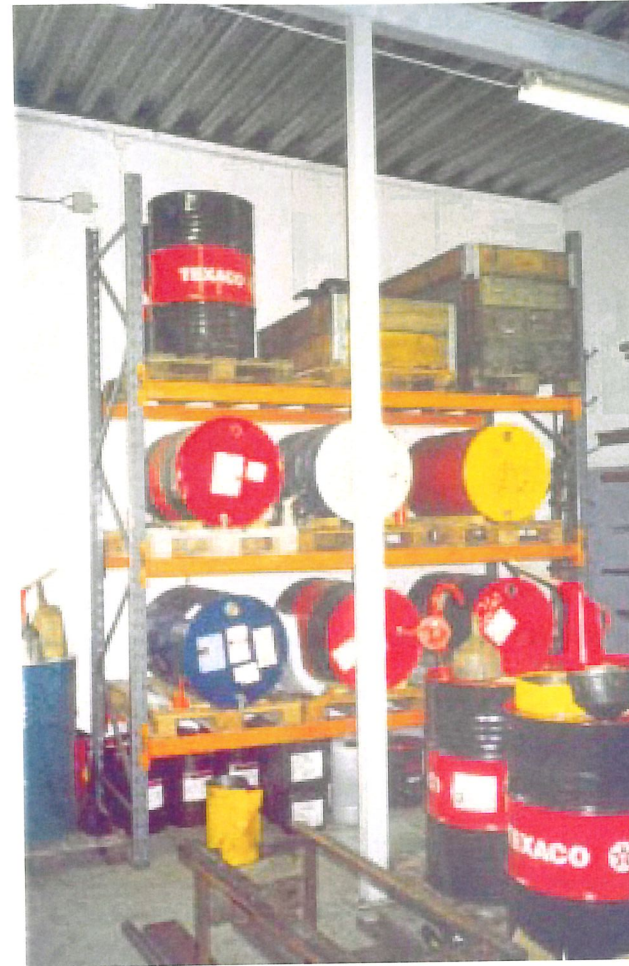
Lubricant oil is used for maintenance of the machines. Approximately 10 drums are used per year. The lubricant oil is stored in the compressor room located in the most western part of the production building (no. 1). A number of 7 drums fitted with taps were placed on a rack. No secondary containment was present below the drums. Cans containing different oil products were located below the rack, directly on the floor. Minor staining could be noticed on the floor (which was painted concrete. The painting was old and the floor could be noticed). No drainage outlets were present in the compressor room.

Storage of oil products and waste oil

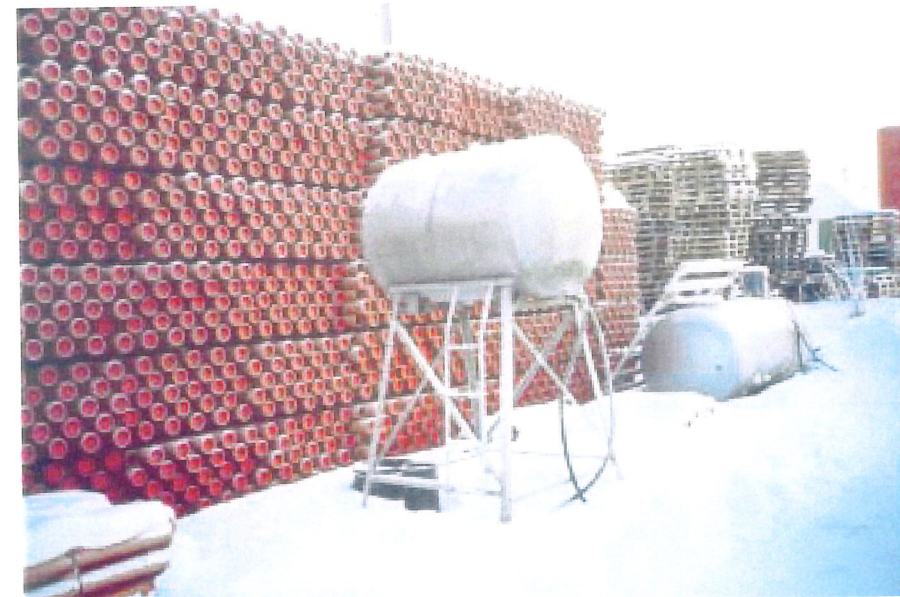
Also a content of total hydrocarbons was detected in soil next to the 3 m<sup>3</sup> AST, indicating that spill occurs when refuelling the fork-lifts and/or filling the AST.

A 3 m<sup>3</sup> AST for diesel oil used for fuelling the fork-lifts is located in the southern part of the outdoor storage area for finished products. The tank is from 1998 and is placed directly on the paved surface. In one end of the tank an area with no paving could be noticed. A filling pump is connected to the tank. No signs of staining could be noticed in the snow. The snow and ice made it impossible to notice whether the ground around the tank was stained. A copy of the tank certificate for this tank was provided.

- A 3 m<sup>3</sup> AST for diesel oil used for fuelling the fork-lifts is located in the outdoor storage area. The tank is 2-3 years old and is placed directly on the paved surface. In one end of the tank an area with no paving could be noticed. A filling pump is affiliated with the tank. No signs of staining could be noticed in the snow. The snow and ice made it impossible to notice whether the ground was stained.

The two AST's for diesel oil

The amount of contaminated soil found by the 3 m<sup>3</sup> AST is not known, but assuming a total volume of 50 m<sup>3</sup> the cost of removal, transportation, disposal of oil contaminated soil and refilling with clean materials will be in the order of 15,000 EUR.

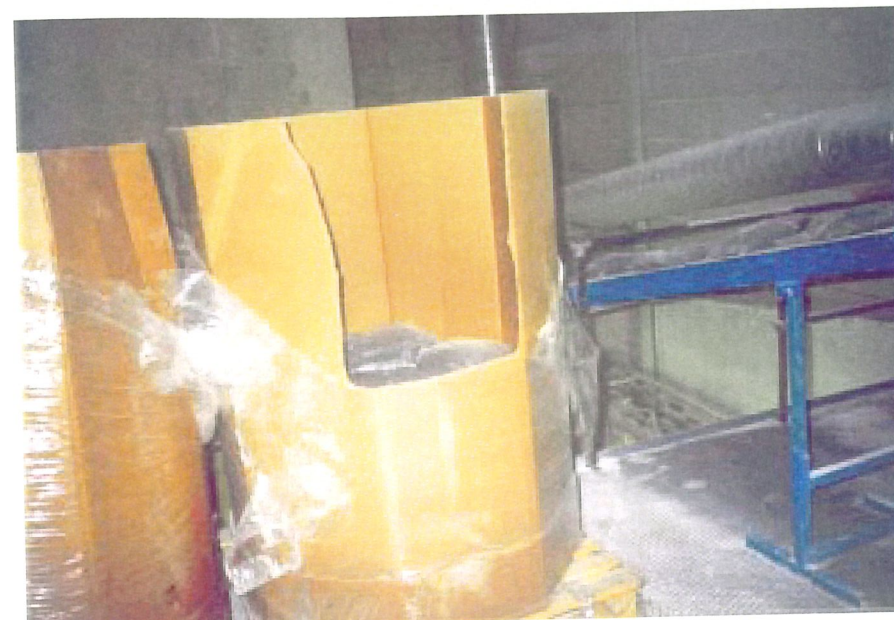
Storage of lead containing products on an inserted deck

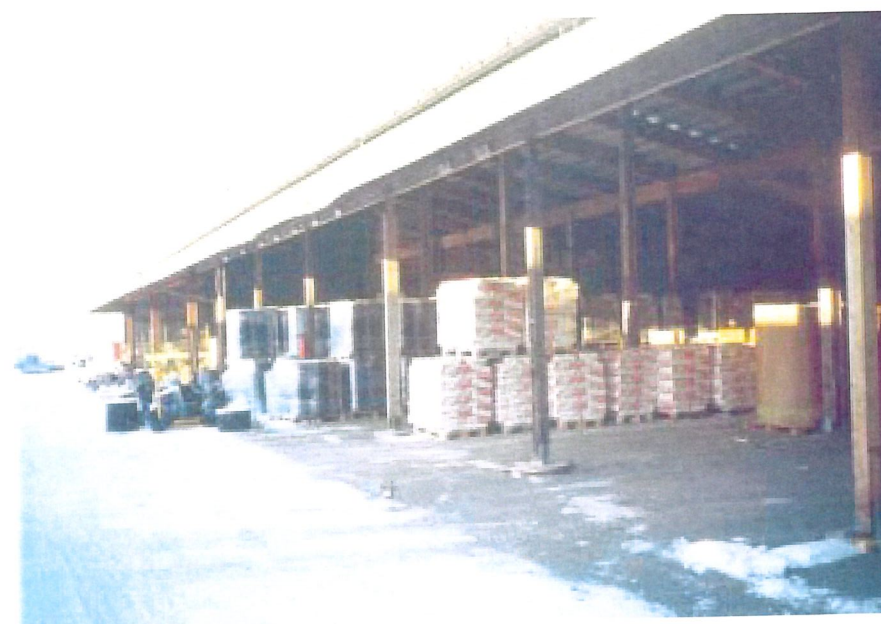
Storage of masterbatches in the shed
